LTI: diver injured during water jetting operations

Safety Flash Published on 20 July 2018 Generated on 28 January 2026 IMCA SF 15/18

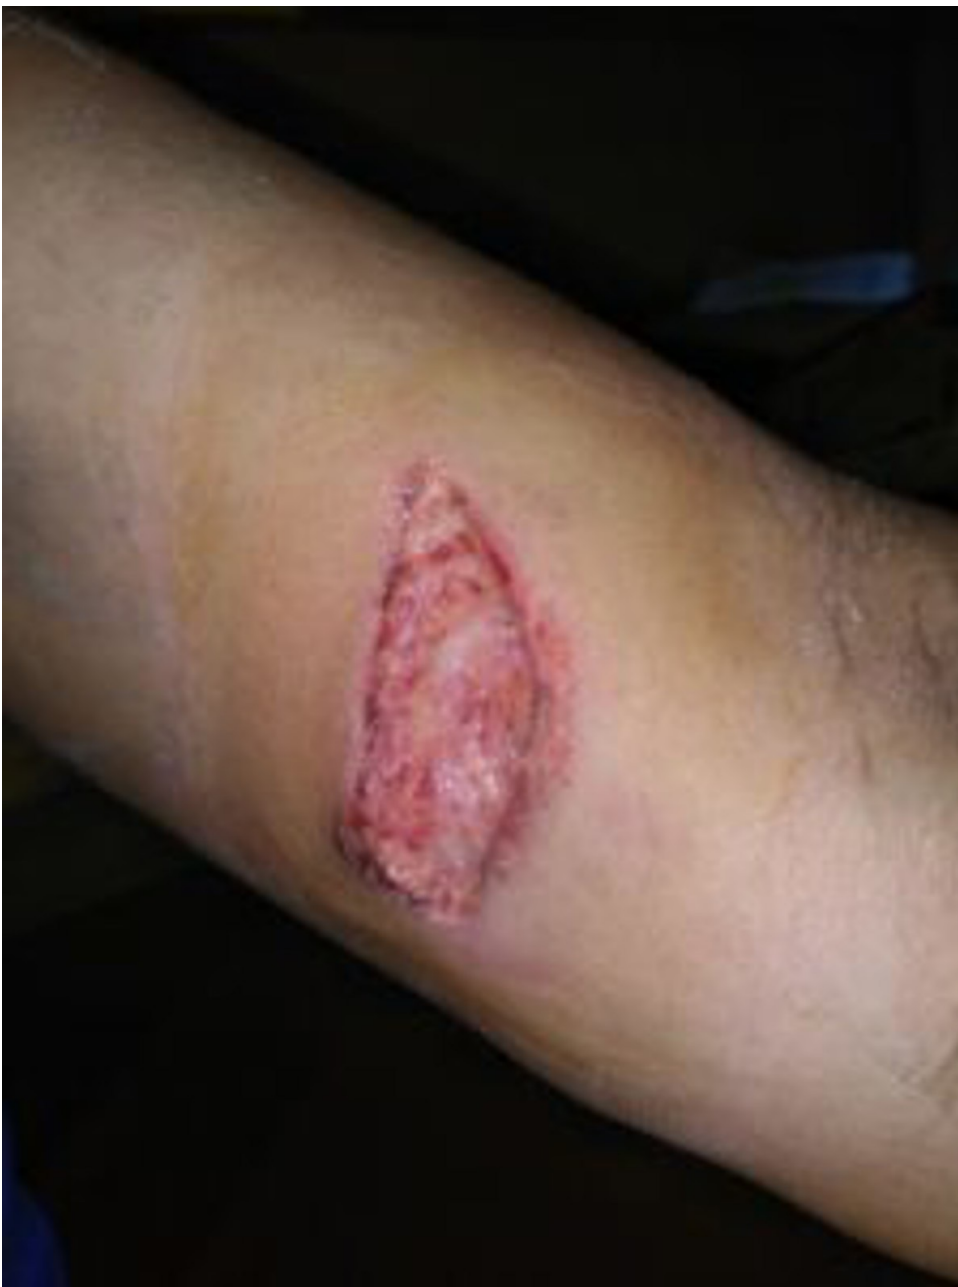
The incident occurred when the water jet gun failed, and a part came off the gun. The diver was recovered to the bell and the water jet gun to the surface. The diver received first aid in the bell and further treatment later in the chamber. He was subsequently decompressed and transferred to hospital. Though an LTI, the injury was not severe, and it was expected that the diver would return to his duties within months.

- Equipment failure: locking bolts on the water jet retro came loose.
- Unsafe design or construction: locking nuts did not have a holding mechanism besides the threads available.
- Improper worker training/familiarization: manufacturer manuals provided were not available at worksite. There was no awareness of the need for a planned maintenance system (PMS) for high pressure equipment of this sort.
- Improper maintenance: it was observed during investigation that maintenance was not carried out in accordance to manufacturer's recommendations.

- Management of change (MoC) prepared for required changes.
- Ensure equipment is maintained in accordance with [Code of practice for the use of high pressure jetting equipment by divers](#) (IMCAD 049) and

any manufacturer's recommendations.

- Additional controls put in place to ensure the water jetting equipment is in safe condition, including checking condition of diffuser and locking nuts.
- Further awareness briefing given to dive team regarding checks of the equipment as per the manufacturer's recommendations.
