Man overboard fatality

Safety Flash Published on 5 July 2019 Generated on 22 January 2025 IMCA SF 16/19

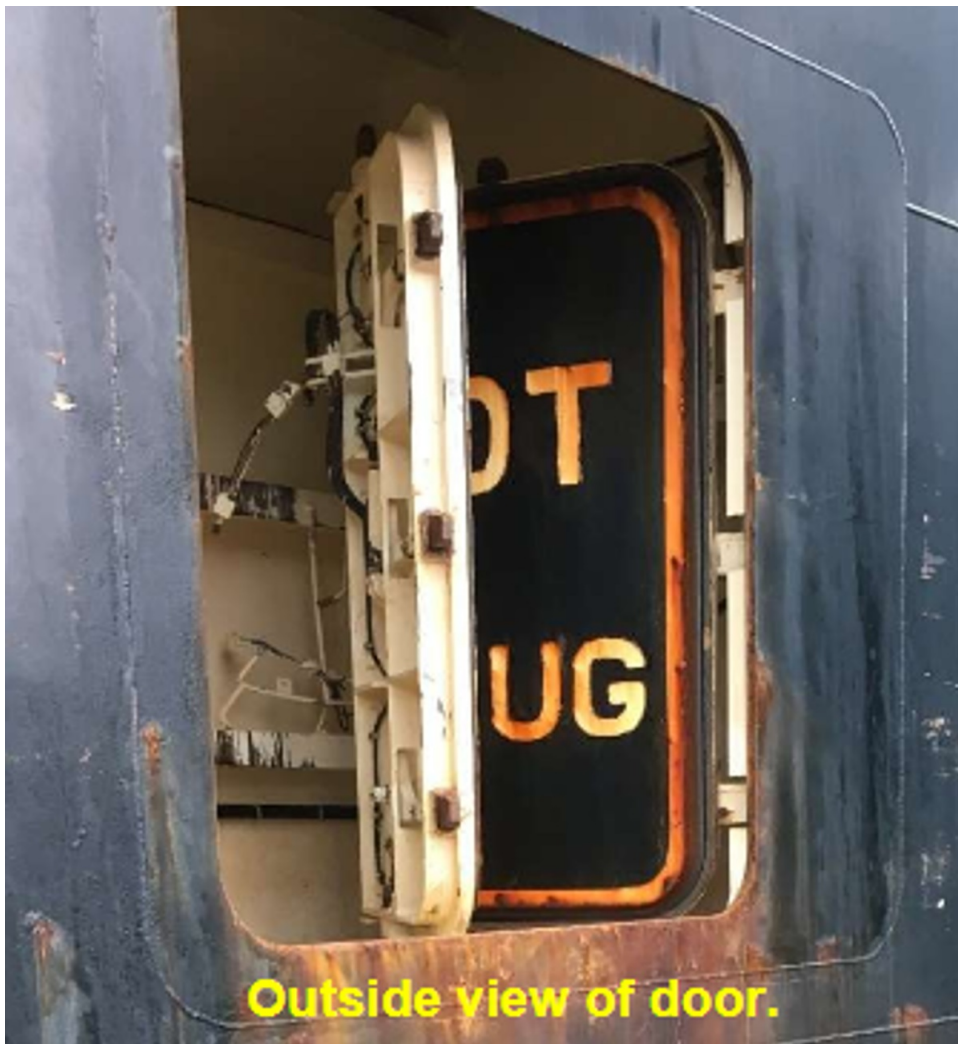
Two crewmen were preparing for the pilot's arrival, behind the hydraulically operated bi-fold hatch door. This was located forward of the bridge and approximately 4 m above the waterline – see photographs.

As the vessel manoeuvred, it was hit by heavy seas that forced the hatch door open, resulting in flooding of the embarkation space, sweeping one crewman out to sea and injuring another.

The injured crewman suffered a broken leg when the pilot ladder fell on him. The hatch door itself was damaged.

Outside view of door.

- The two crewmen were unable to see the sea from their position behind the hatch door. As they opened the door, seas unexpectedly struck and violently forced it open, flooding the space.
- One of them was not wearing a harness or safety line, nor a personal flotation device and was washed overboard and subsequently swept out to sea.

Even though the side hatch door was located on the port side and was being brought onto the vessel's lee, the crew's inability to observe and assess the sea conditions combined with the ship's roll and sea state presented significant risks.

- A thorough review and update of vessel Safety Management Systems (SMS), procedural manuals and guidance that relates to pilot transfers.
- Reinforce the importance of wearing personal protection devices and safety lines when working over the side of a vessel, when exposed to the elements or when there is an absence of barrier that could prevent an accidental water entry.
- Ensure officers and crew identify potential hazards and conduct a risk assessment, to include a consideration of weather conditions, prior to opening hatch doors of this sort.
- Ensure crew communications between navigation watch officers and crew, in situations such as this, are clear and provide suitable supervision of activities, considering sea state and other changing conditions. Members may wish to search the [Safety Flash Archive](#) for terms such as *pilot* or *man overboard*.
