Sprained ankle whilst climbing on equipment

Safety Flash Published on 5 July 2019 Generated on 21 January 2025 IMCA SF 16/19

A crewman slipped and sprained his ankle climbing off equipment on which he had been working

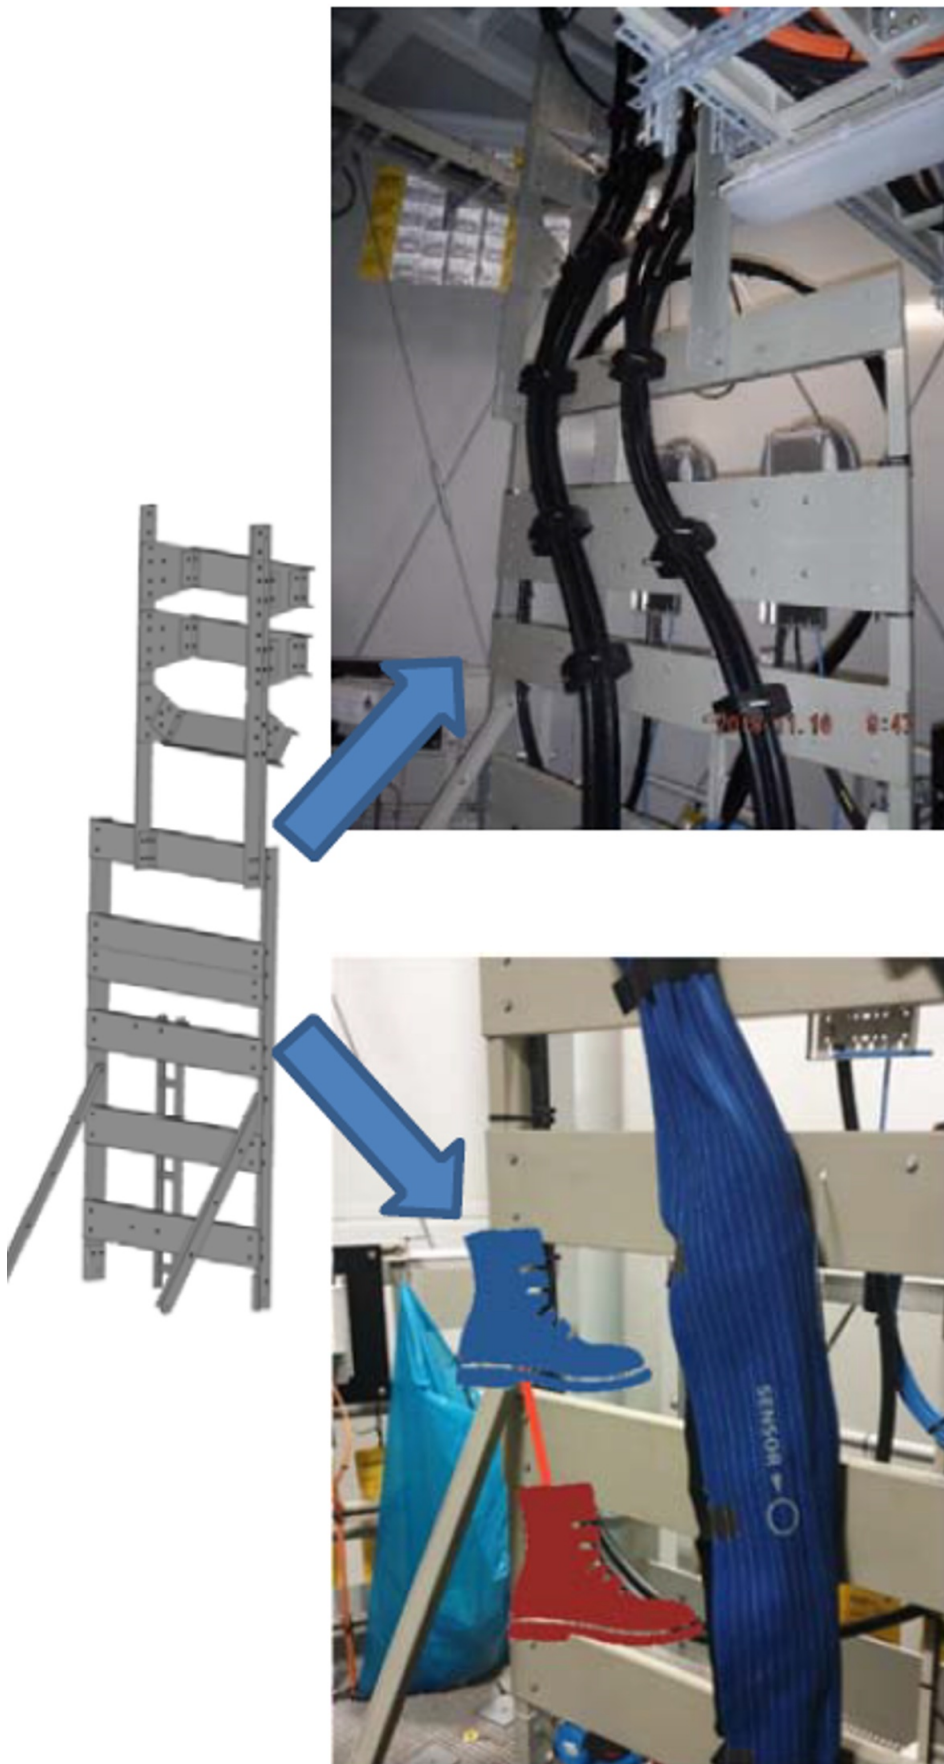
The incident occurred inside a transition piece (the lower part of an offshore wind turbine tower).

A crewman was climbing down off a cable rack (on which he had climbed to loosen cable cleats and apply a heat blanket) when he slipped off and twisted his ankle, losing balance and falling onto the floor.

- The cable rack was not designed to be climbed on; the spacing between rungs varies and does not follow the standard for fixed ladders.
- Access to the work location on top of the cable rack was not addressed in the

risk assessment and the related procedure.

- Inadequate mitigations implemented; the narrow workspace in the transition piece does not allow the use of stepladders and work platforms.

- Identify hazards at design stage to ensure that safe access can be achieved.
- Before starting work, safe access to any site should be established. If this can't be achieved, then STOP the job and report the issue to your Supervisor.
- Ladders and platforms – safe and appropriate to the conditions should be used and working at height processes should be followed.
