## MSF: Grease gun hand injury

Safety Flash Published on 4 September 2025 Generated on 28 January 2026 IMCA SF 16/25

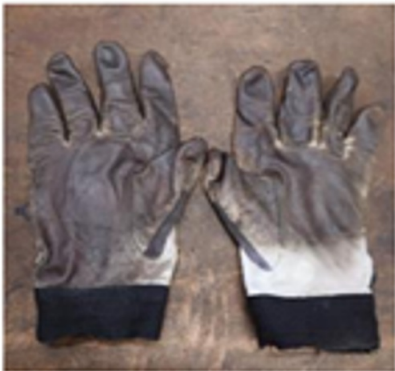
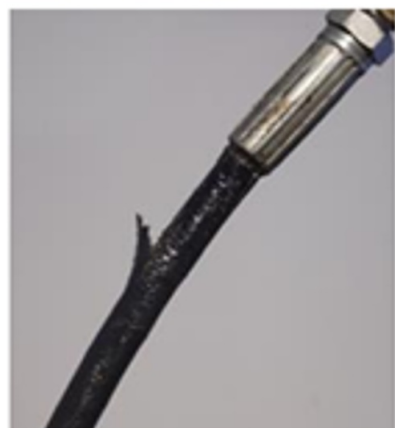
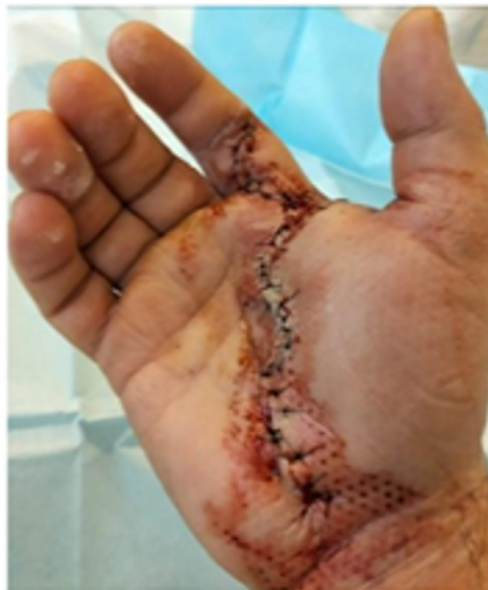
The Marine Safety Forum have published [Safety Alert 25-08](#) relating to a hand injury suffered when a grease gun burst. The incident occurred during routine greasing of a tensioner unit using an electrically powered battery grease gun, when the hose burst and grease punctured the operator's hand. The crew member was wearing full PPE and performing the task in accordance with safety procedures that were in place at the time. As the crew member attempted to remove the greasing hose from the greasing point, the hose burst on his right hand. The high-pressured grease passed through the damaged hose causing a penetration through his glove, leading to a small open wound on his skin. The crew person immediately attempted to remove as much grease as possible from the wound and proceeded directly to the onboard medic for evaluation and treatment. Following consultation it was decided to sail back to port for medical attention at local hospital

- Immediate Cause
  - The pressure release valve in the grease gun did not function as expected, causing grease to be injected at high pressure.
- Underlying Cause
  - It was possible that the grease gun was not properly or safely handled due to lack of experience, insufficient training and lack of awareness of the hazards involved.
  - The injured person was unaware of the high pressure in the grease gun system at the time, therefore he began to exert effort on the grease hose to remove it from the grease nipple. The grease hose was (most likely) unable to handle the pressure and collapsed. This resulted in a grease injection through his glove and skin into his right hand.

- High-pressure grease guns have the potential to cause serious injury or even death if not properly used and properly maintained. Grease in this type of equipment is under pressure up to an operating pressure 69 MPa (10,000 psi).

- The velocity of grease forced through a pinhole break in a hydraulic hose can be in excess of 250 metres per second (600ft/s). This is close to the muzzle velocity of a rifle, and is sufficient to drive fluids through protective clothing, including protective gloves.

- Penetration of the skin can occur at pressures as low as 100psi - BE AWARE of the dangers of high pressure injected injuries.
- Ensure grease guns are used in compliance with equipment manufacturers instructions.

- Inspect the integrity and security of grease nipples and hoses prior to starting the task.
- Ensure correct gloves are used with grease guns.
- Can greasing be done with a different kind of tool that is safer?
