LTI – person fell from step ladder

Safety Flash Published on 29 August 2024 Generated on 25 April 2025 IMCA SF 17/24

A worker fell off a 2-step ladder/hop up and was injured resulting in an LTI.

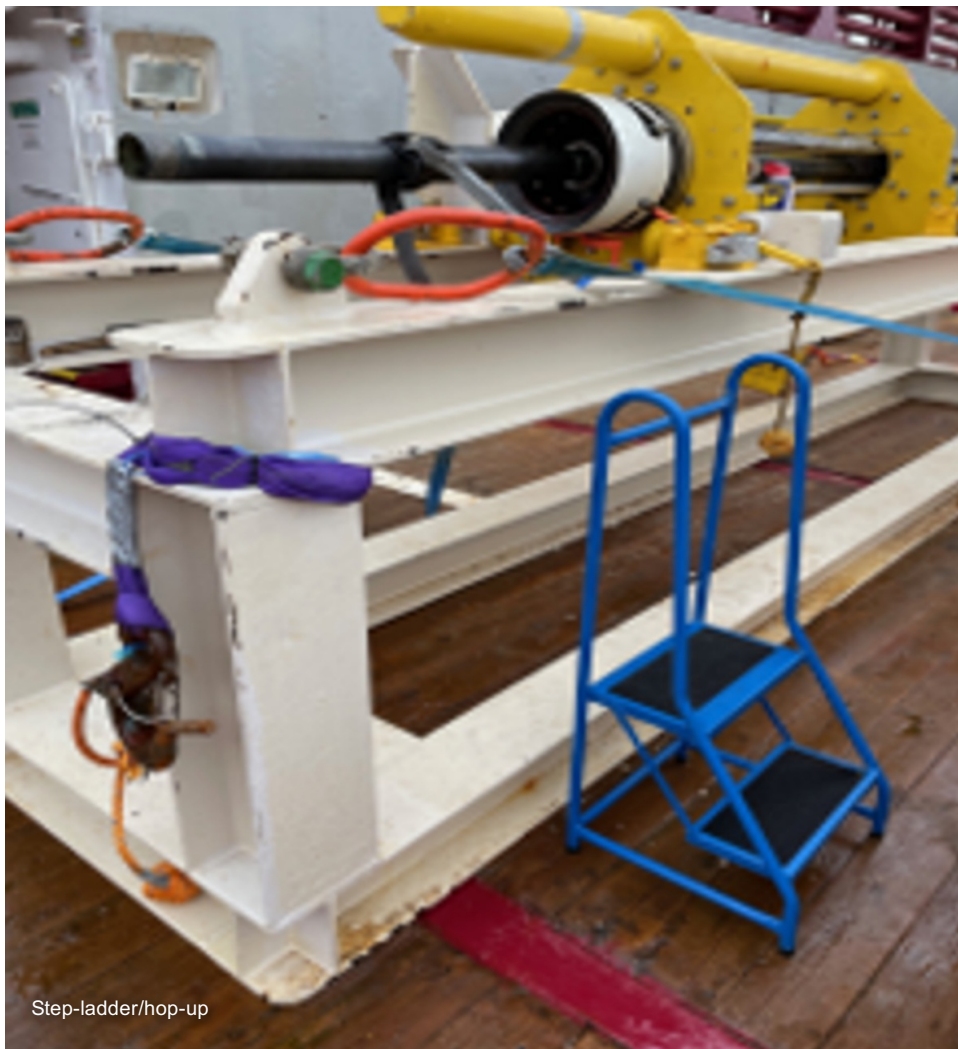
While the worker was on the 2-step ladder/hop up, the vessel hit a wave and pitched, and this caused the worker to lose balance and fall. The step ladder/hop up went to the right and the person fell to the left struck their ribs on the frame of the tool and then fell to deck. In pain, the worker went to see the vessel medic, who after assessing the situation, transferred the worker ashore for further assessment and treatment. The diagnosis was a fractured rib. The worker was unable to return to work and went on sick leave.

The height from deck to the tool was 1.6m and the step ladder was 0.5m in height to the top step. At the time of the incident, the sea state was 2 m significant wave height, and the deck planks were wet.

- The ladder/hop up was not secured to a fixed point as required in procedures.
- The hazard/risk of using the two-step ladder had been identified in the risk assessment, but the mitigating actions were not satisfactory. The equipment was not robust enough.

- Even falls from low heights can result in serious injuries.
- Could the work have been done when the sea was calmer?
- Ensure such equipment is properly secured before use.
- An engineered solution was to be prepared, for a fabricated access point on the tool frame, to negate the use of a temporary step ladder.
