MSF: Air Cylinder – High Pressure Discharge

Safety Flash Published on 29 August 2023 Generated on 22 January 2025 IMCA SF 21/23

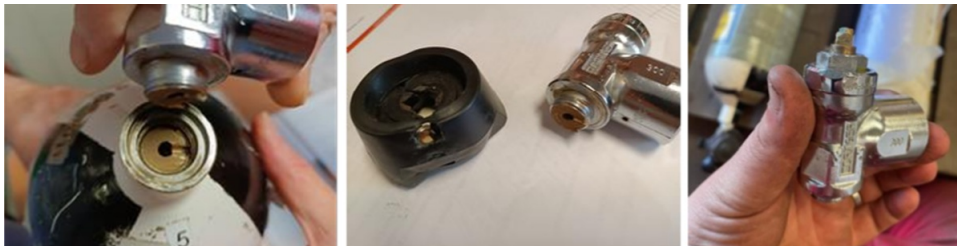
On inspection of the damaged valve, it was found that there was a fracture of the threaded end which had resulted in failure along a crack likely caused by metal fatigue.

The cylinder and associated fittings were sent for further investigation, and the investigator noted that there was evidence that the pillar valve had *“seen a heavy impact, the nut retaining the handwheel has been pushed through the handwheel itself and ...what is left of the spindle has also seen a heavy impact along with the valve itself.”*

It was the opinion of the investigator that the cylinder had been dropped onto the valve causing it to break. This was considered a very serious incident that ultimately could have caused a fatality.

- When moving pressurised cylinders around the vessel extreme care should be exercised.
- When decanting cylinders for transportation, the cylinder should be held securely with the valve being slightly cracked open with the contents being released in a slow and controlled manner.
- Always make sure that the valve end of the cylinder is pointing away from yourself and any colleagues.
- When conducting this operation full PPE should be worn.
- The vessel owner is investigating the fitting of Excess Flow Valves when individual cylinders pass through the maintenance workshop.
