Confined space fatality – Sharp Lady

Safety Flash Published on 1 September 2016 Generated on 14 January 2025 IMCA SF 22/16

The Isle of Man Ship Registry has published Casualty Investigation Report No. CA118 on a confined space entry fatality that occurred on a crude tanker.

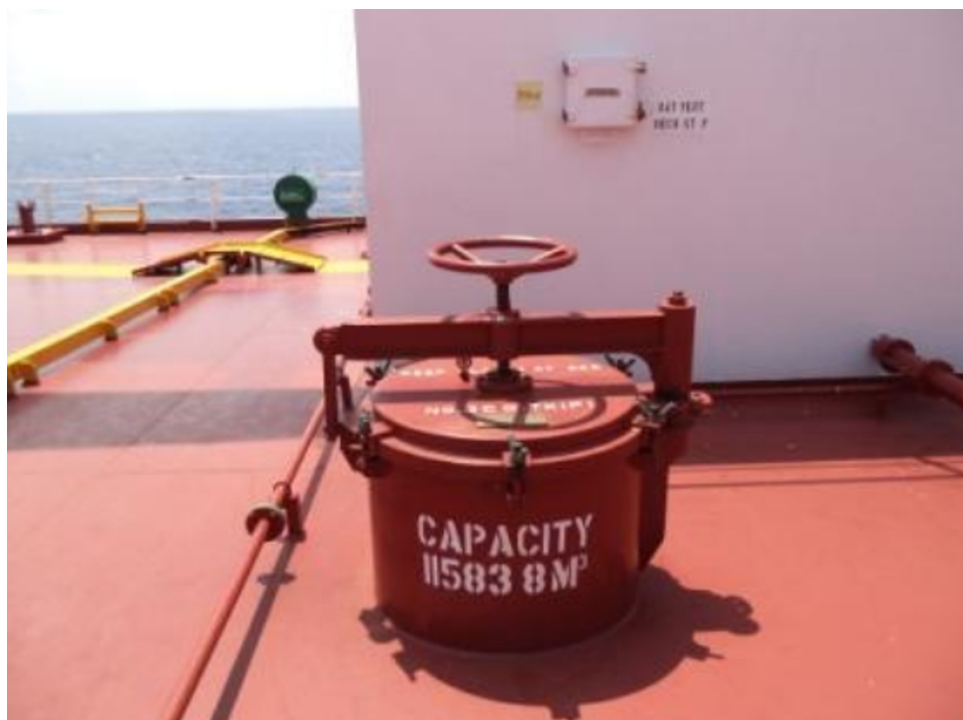
The incident occurred after discharging crude oil. Equipment was lost at the bottom of a tank. It was decided that once the discharge was finished and crude oil washing completed, the equipment should be retrieved before loading the next cargo into this tank, to avoid any potential damage to the ship's equipment.

The Chief Officer and Cadet entered the cargo tank after an enclosed space work permit and risk assessment had been completed. When the Chief Officer and Cadet reached the bottom of the cargo tank they felt debilitating effects of hydrocarbon vapour present at the lower level of the cargo tank. Both the Chief Officer and Cadet attempted to activate their Emergency Escape Breathing Devices (EEBD) and exit the cargo tank.

The ship's safety procedures for enclosed space were not fully complied with and the risk posed by the hydrocarbon vapour measured in the cargo tank was not appreciated by those involved in the tank entry preparations.

The report also concludes that opportunities were missed on board to stop the tank entry by several crew members and that the death of the Master could have been prevented had the safety procedures on board been followed in full.
