Hand Injury

Safety Flash Published on **25 September 2018** Generated on **17 January 2025** IMCA SF 22/18

The Bureau of Safety and Environmental Enforcement (BSEE) has published **Safety Alert No. 336** regarding a hand injury sustained during lifting procedures.

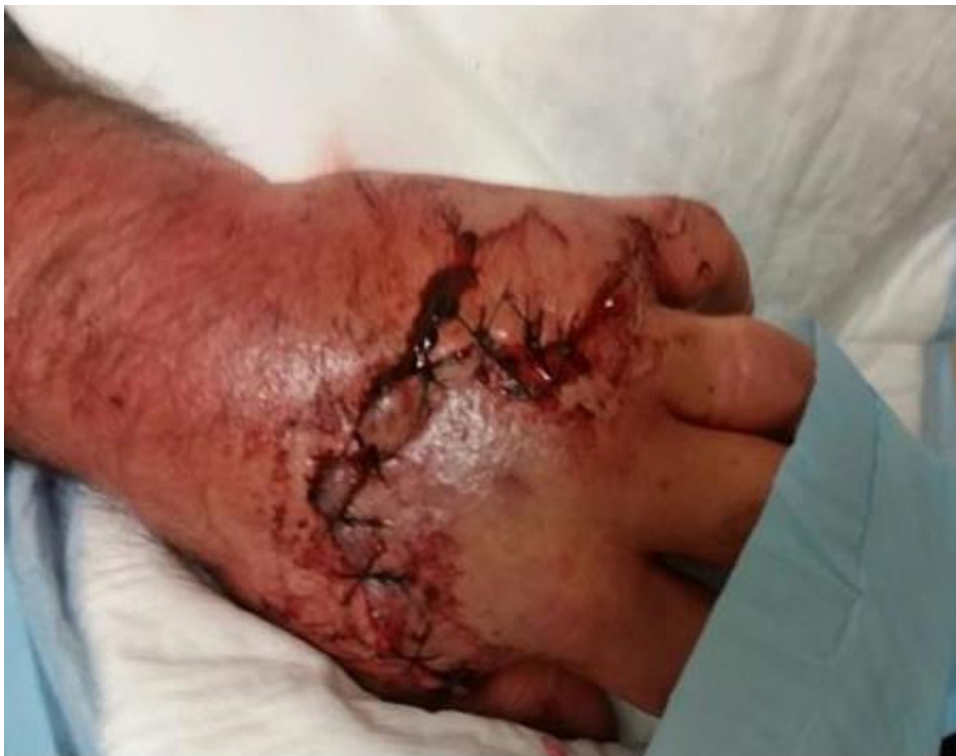
During a slow lifting process to remove a rubbish bag from a storage container, the storage container itself also began to lift. The crane operator was unable to see the lifting operation due to a blind spot, and therefore had another employee guiding him through the lift. The employee placed his hand on the container in order to free the bag. As the container began to lift, the metal frame began to part, which caused the container to fall onto the production deck and the individual.

The employee was left with a large laceration (see image) on his left hand, which required 8 stitches.

- The correct personal protective equipment (PPE) was not worn by the employee guiding the crane operator.

- The storage container was removed from service and discarded.

- Offshore personnel should always wear appropriate PPE when performing tasks.
- The BSEE also recommends that operators use job safety analyses (JSAs) on each job/task undertaken and ensure that they properly identify the risks and hazards of the job, and to mitigate the risks to as low as is reasonably practicable (using the hierarchy of controls promoted by NIOSH).
