## UK HSE Investigation into Offshore Gas Explosion

Safety Flash Published on 30 September 2019 Generated on 24 January 2025 IMCA SF 23/19

The UK HSE has fined Marathon Oil UK LLC (Marathon) £1,160,000 following investigation into a high-pressure gas release on the Brae Alpha offshore platform on 26 December 2015.

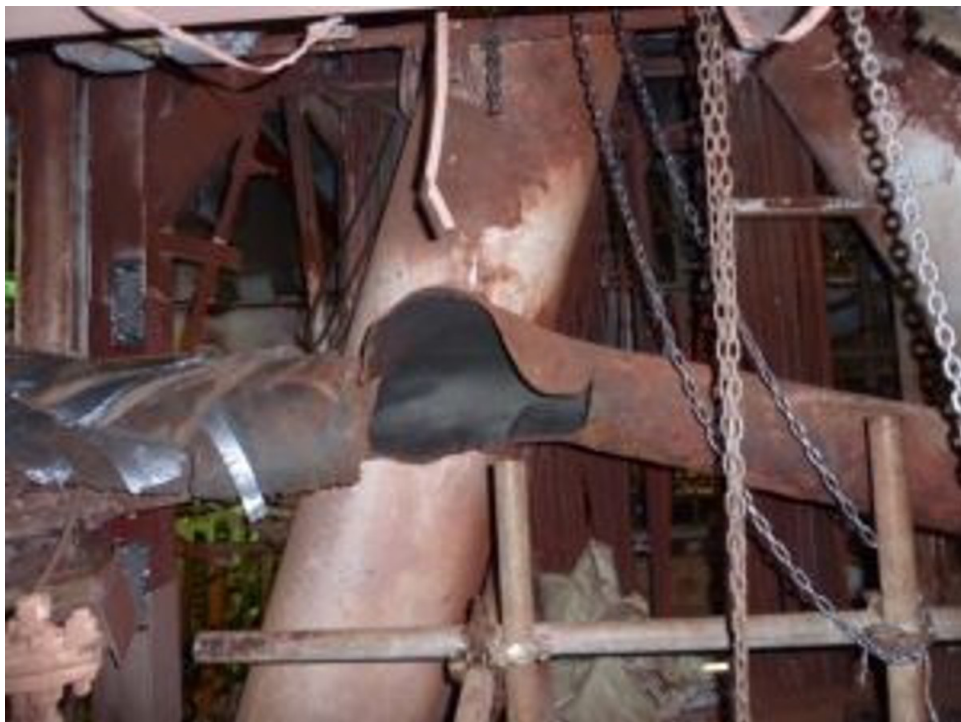
Eight-inch (20cm) diameter high pressure pipework in Module 14 on the platform suffered a catastrophic rupture as a result of 'Corrosion Under Insulation' (CUI), allowing over two tonnes of high-pressure methane gas to be released almost instantaneously.

The force of the high-pressure release caused significant and widespread damage in Module 14. Fortunately, owing to the timing of the incident, there were no injuries.

Investigation found that Marathon Oil had failed to undertake any suitable and sufficient inspection of the pipework that would have allowed the company to identify the risk and prevent the hazard from materialising.

explosion, and also led to the UK HSE serving an Improvement Notice on Marathon Oil in January 2016, requiring the company to implement an effective hydrocarbon pipework inspection and maintenance regime.
