Rope access technician slipped and dislocated shoulder

Safety Flash Published on 3 October 2023 Generated on 21 January 2025 IMCA SF 23/23

A rope access technician dislocated his right shoulder while accessing the vessel transom port-side platform, following buoyancy module pad retrieval from the pipe string.

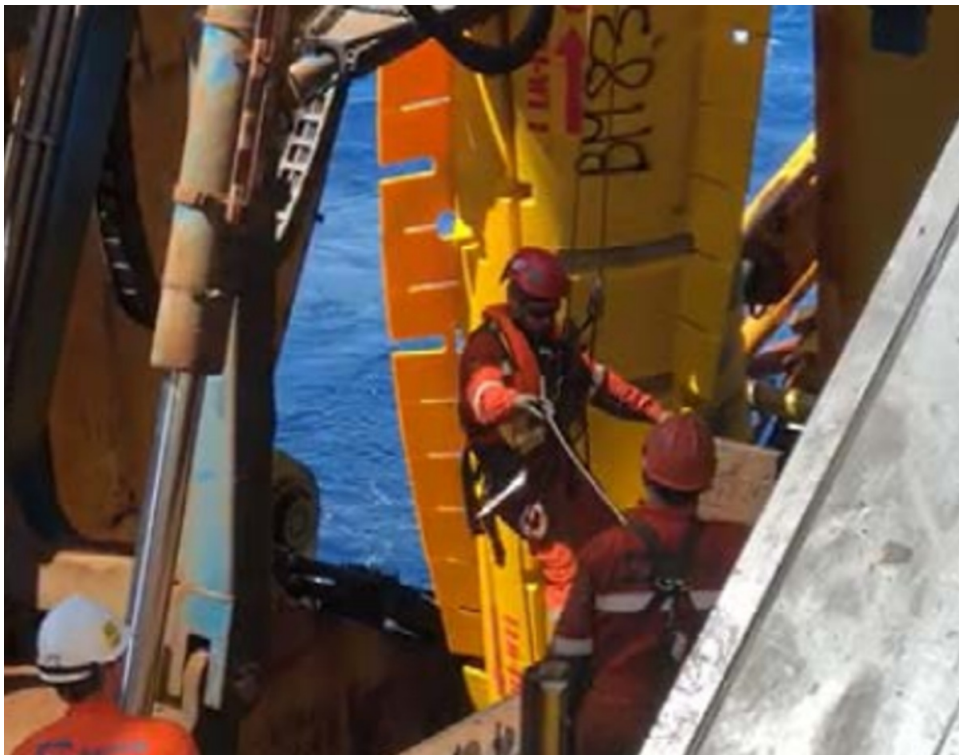
The rope access technician lost grip after stepping with both feet on the wet and slippery handrail (angled stiffener).

Due to the wet, slippery environment and due to one grease-contaminated glove, he was unable to sustain his body weight with his hands and fell simultaneously rotating his body which was still connected to the ropes, leading to a dislocated shoulder.

Rope access technician lost grip after stepping on slippery handrail

Our Member noted the cause as inadequate risk planning and risk assessment.

- For rope access operations in particular, task planning and Job Safety Analysis should be exhaustive and detailed.
- Taking shortcuts, no matter how trivial, has the potential to trigger a chain of events that can lead to an incident.

- Held a safety stand-down with the rope access subcontractor.
- Raised awareness on hazards and risks associated with slips, trips and falls.
- Arranged refresher training in Job Safety Analysis and Risk Assessment for rope access teams.
