## Vital safety information (height of vehicle) found incorrect

Safety Flash Published on 27 November 2024 Generated on 4 December 2024 IMCA SF 23/24

“Height of vehicle” information displayed on a truck, was found to be incorrect.

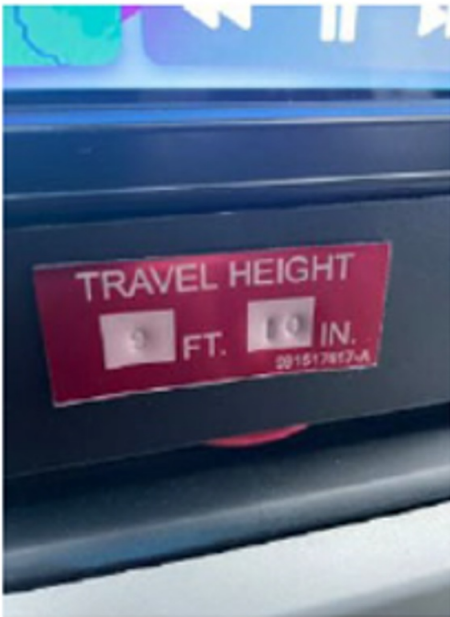
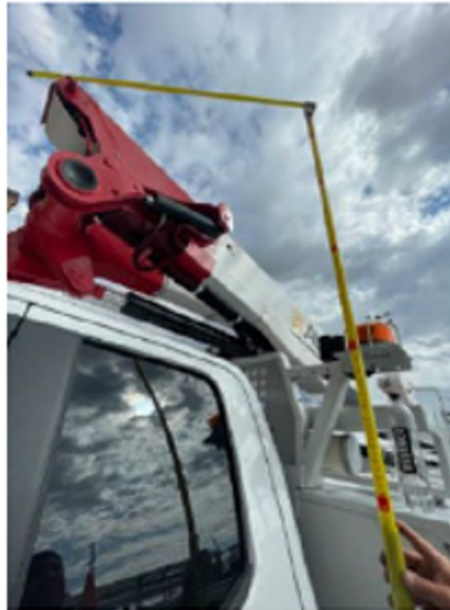
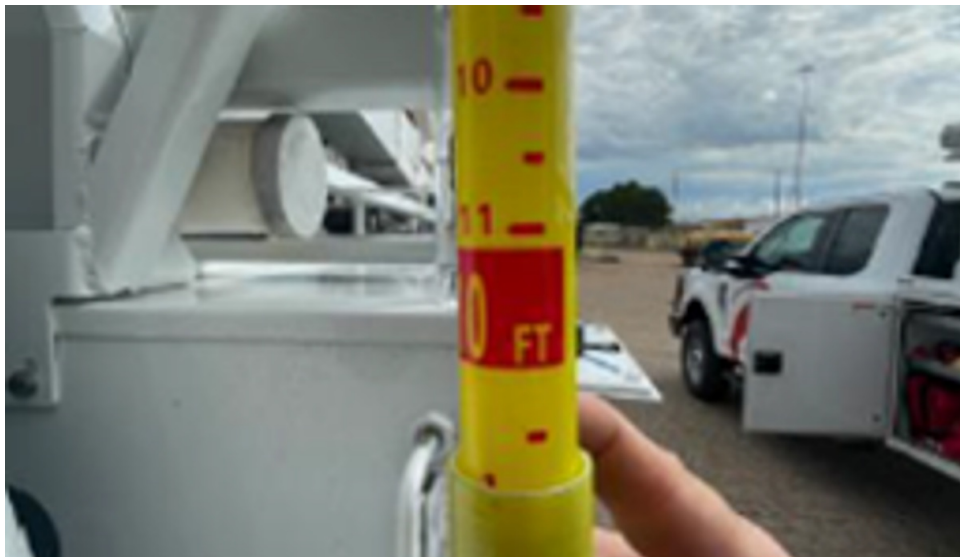
An IMCA member’s contractor in the United States reports an incident in which it was discovered that the “height of vehicle” information displayed on a truck, was found to be incorrect. A worker was moving a light industrial vehicle (a “bucket truck” with a bucket on a folding hydraulic arm) when the correctly stowed folding arm came into contact with an overhead structure. There was no damage.

On investigation, it was found that the stamped traveling height on the truck was different from the actual traveling height. The actual traveling height was verified by careful measurement. The truck was stamped with a traveling height of 9 feet and 10 inches (300 cm) but the actual measured traveling height was found to be 10 feet 1 inch (307cm).

Subsequently all similar vehicles in the fleet were measured and it was discovered that three out of four trucks measured also had incorrect stamped traveling height.

- Whilst this incident is about vehicles, the principle applies not only to all industrial vehicles and sometimes private cars, but in general to safety information that we may have assumed for years is correct.
- Consider checking height of vehicle information in industrial vehicles, overhead clearances and other measurements;
- Consider checking how up to date are any printed manuals or instructions you have.
