## Fire in the laundry room

Safety Flash Published on 16 October 2023 Generated on 22 January 2025 IMCA SF 24/23

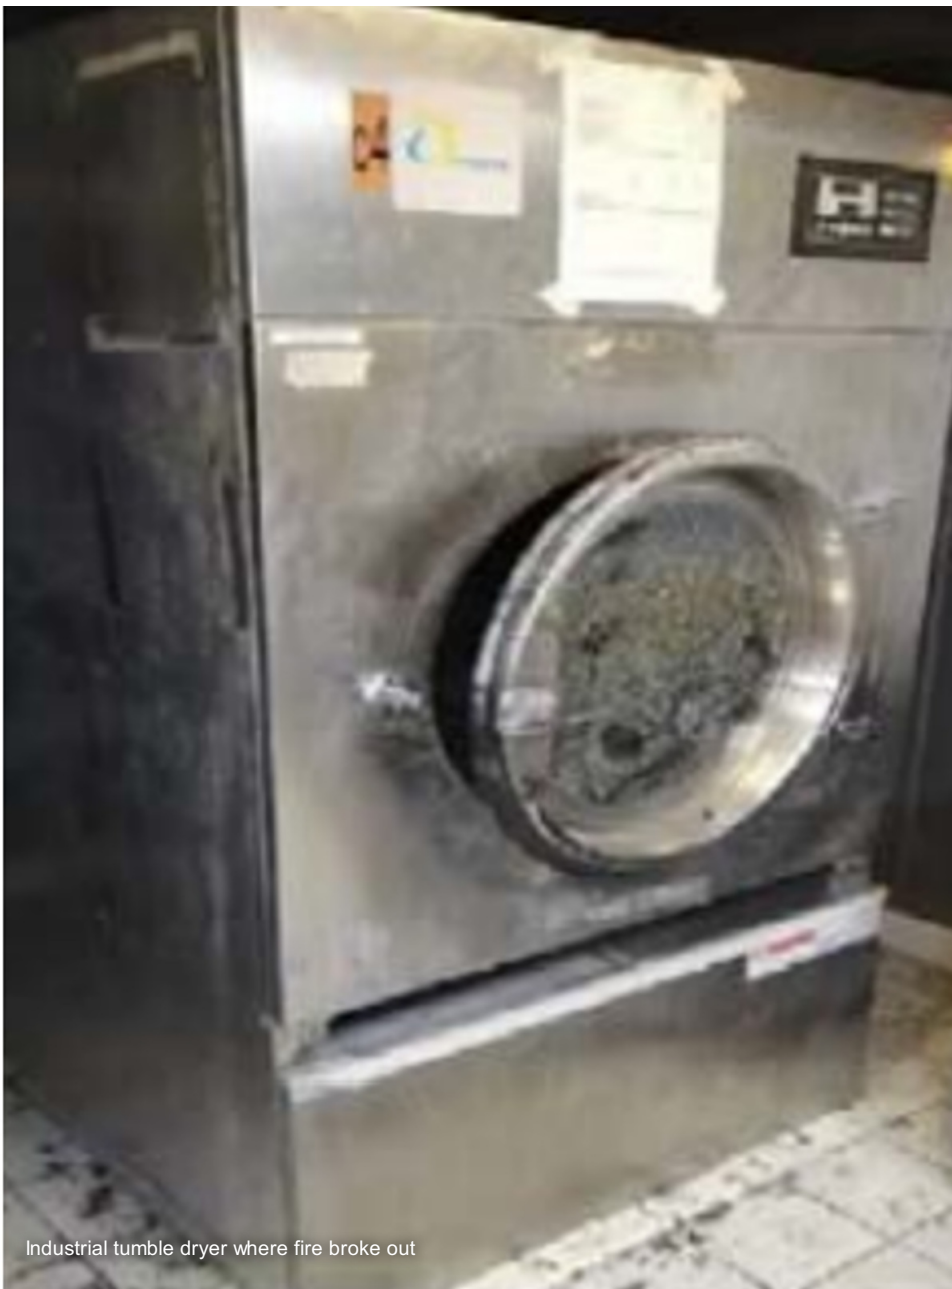
The fire team found the source of the fire which was coming from an industrial tumble dryer in the laundry room.

Industrial tumble dryer where fire broke out

- The air flow of the tumble dryer heating system may have allowed flammable material (particulate) to be conveyed through the electrical heating elements and pushed into the drum containing the clothes. The electrical elements are not protected (isolated) and are positioned very close to the actual rotating drum.
- The dryer had undergone recent maintenance (troubleshooting) and the control panel and set-up parameters had been changed during this process,

and were different from the original.

- There was no smoke detection in the laundry – only heat detectors – and the alarm was by the smoke detector adjacent the door of the laundry in the corridor because the door was partially open.
- The type of tumble dryer conformed to no known industrial standard.

- Changes to the dryer in the troubleshooting/maintenance process.
- Lack of smoke detection in the laundry.

- Use equipment complying with a recognised industrial design standard.
- Use spare parts that are original and/or fully compatible with the equipment.
- Review fire/smoke detection system to identify potential improvements particularly in laundry area.
