Job stopped safely: safe working load limits exceeded

Safety Flash Published on 16 October 2023 Generated on 28 January 2026 IMCA SF 24/23

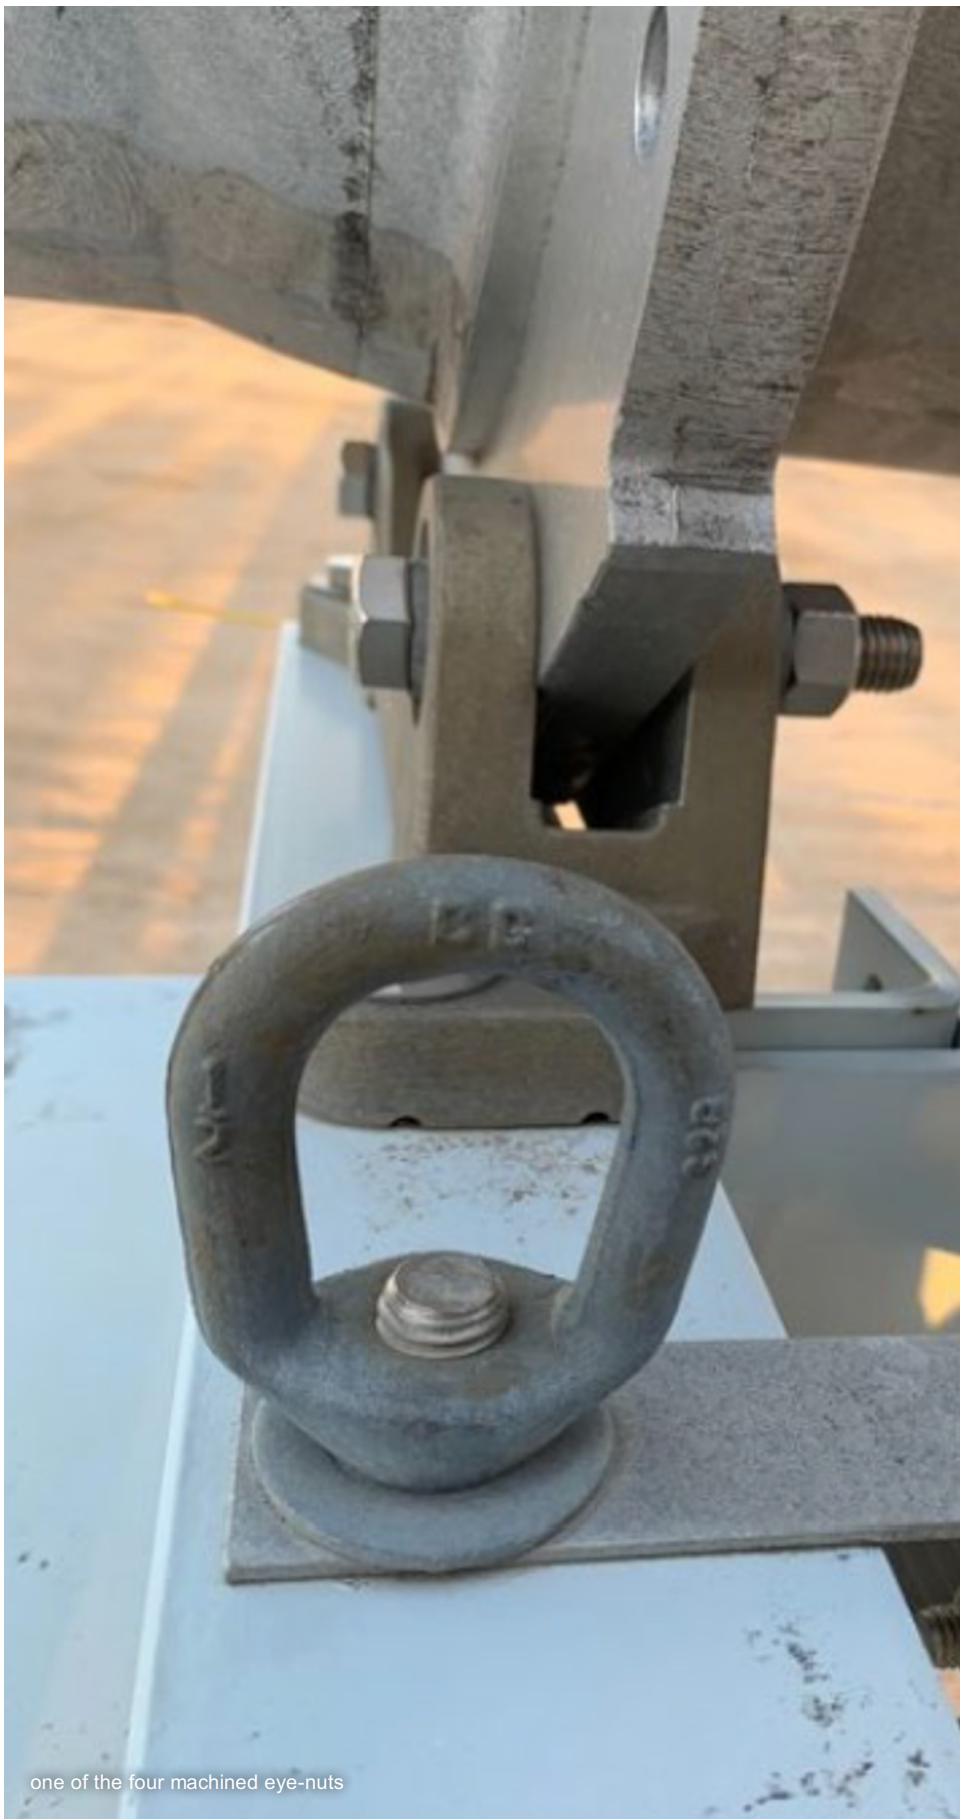
It was discovered that the application of eye-nuts were not consistent with their intended use. The task was to install rigging and lift a something using a 4-leg bridle chain with adjustable length legs. The attachment points, for the 4-leg bridle chain to the load were four machined eye-nuts (see illustration).

After researching the eye-nut, a note was found accompanied with the load chart stating that the eye-nut installed was "for in-line picks only." At that point, work was stopped.

The rigging plan to be used involved rigging on the eye-nuts at a 60° angle. Not only were the eye-nuts not being used as intended, but additionally when picking with sling-angles, load capacities are reduced, which would have put the eye-nuts above their safe working load limit. An alternate load was lifted in this case for training purposes.

one of the four machined eye-nuts

- Work was stopped.
- This was a real-time example of the importance of inspecting and verifying every link in a rigging plan.

- Encourage a questioning attitude and a culture where “there are no stupid questions”.
