Dropped Object from Derrick

Safety Flash Published on 4 September 2020 Generated on 14 January 2025 IMCA SF 26/20

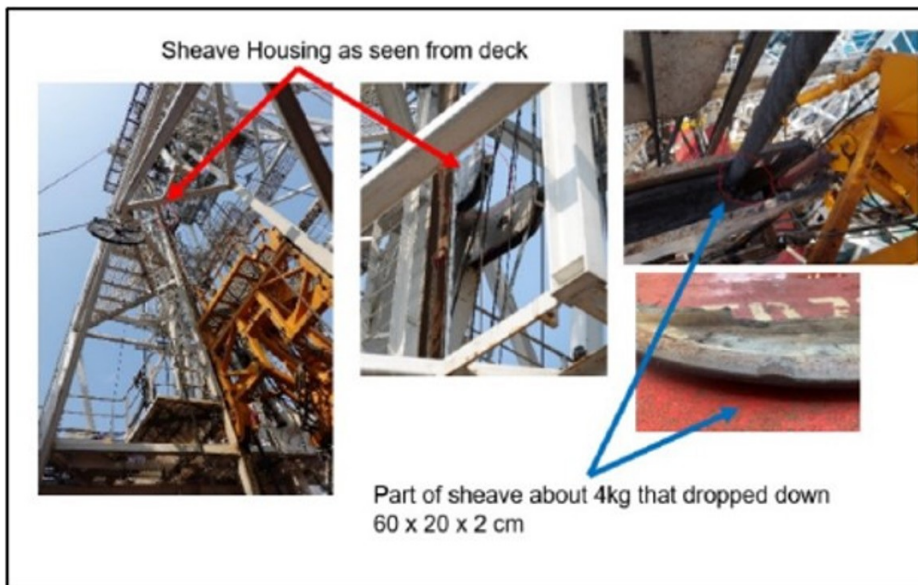
While running in drill pipe on a drilling vessel, part of a guide sheave failed and fell approximately 15 m to the drill floor.

The sheave had seized and failed due to a combination of:

- Design – lack of inspection hole in the sheave.
- A small fleet angle resulting in lateral forces on one side of the sheave.
- Installation – incorrect thickness spacer fitted by a contractor during refurbishment and a lack of a protective coating (paint).
- Quality control – inadequate inspection & testing of the installation / contractor's work.
- Maintenance and inspection – failure to spot equipment defects and inadequacy of secondary retention.

- Amended vessel preventative maintenance system to include more detailed requirements for the inspection of ancillary equipment (e.g. sheaves, floodlights and other potential dropped object hazards) including the details of any applicable standards.
- Implemented Work Report templates to be prepared and submitted by contractors describing completed refurbishment / maintenance works.
- Revised designated 'Red Zones' to include "Safe Standing Zones" with overhead protective shielding.
