## Failure of in-service saturation bailout bottle

Safety Flash Published on 22 September 2021 Generated on 28 January 2026 IMCA SF 26/21

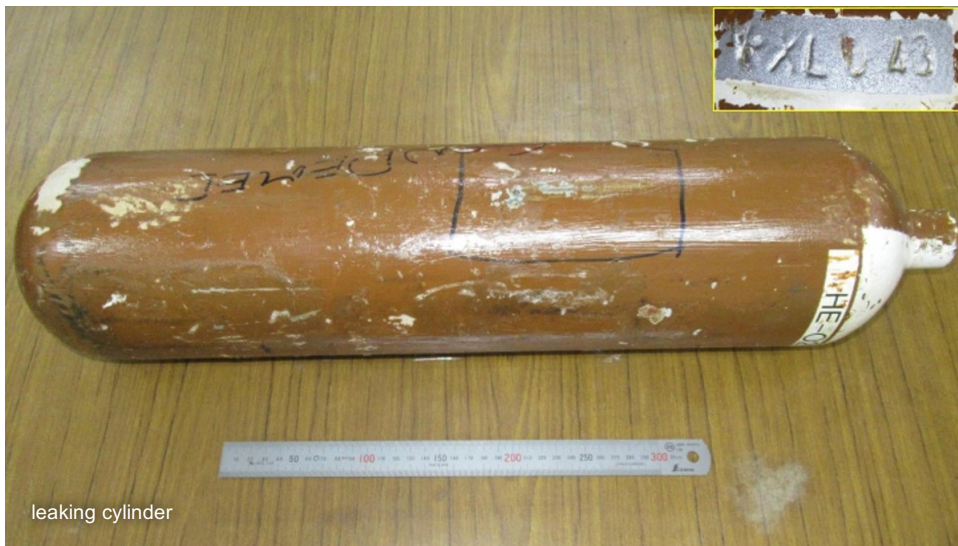
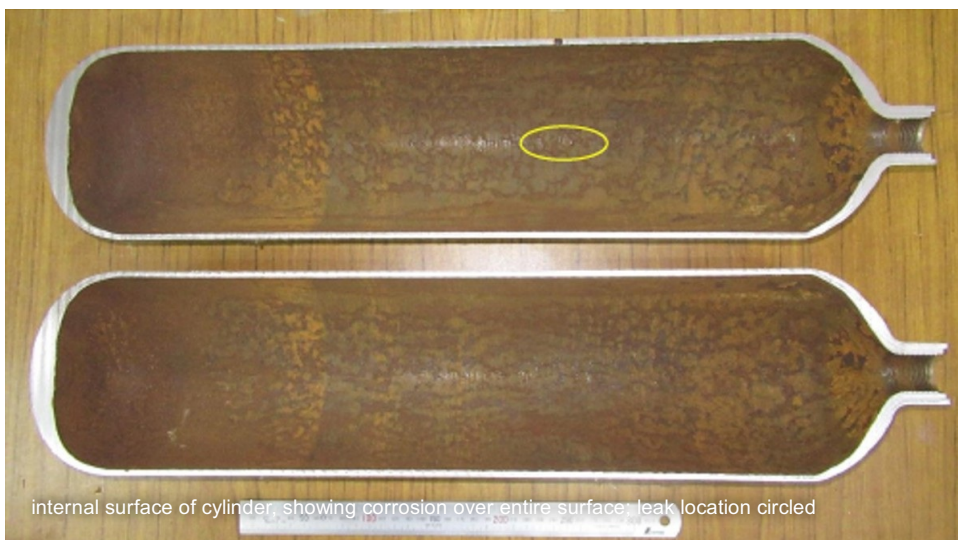
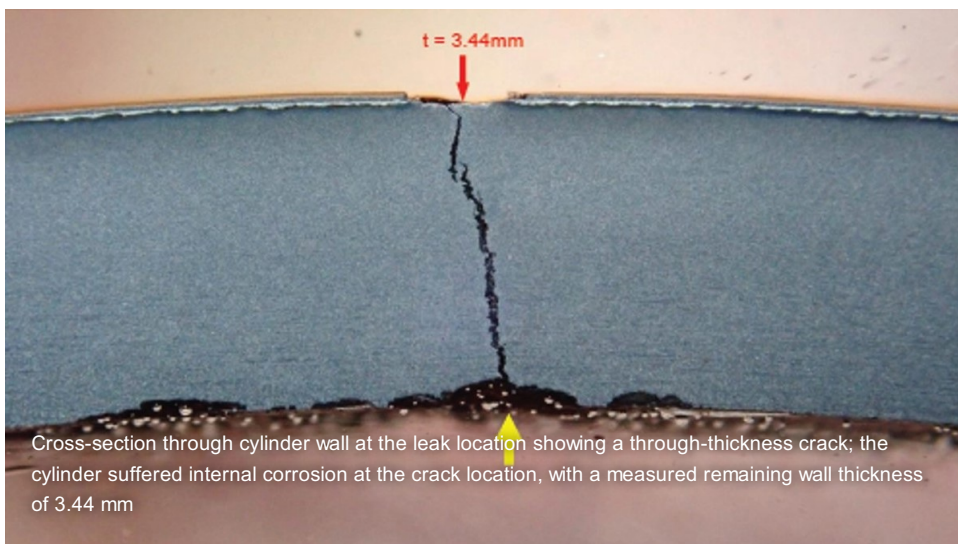
Upon recovery to deck, the bailout bottle was found to have 3 pin holes on the side wall hidden by a locking clasp. Saturation diving operations were suspended and all bailout bottles from the same manufacture of the same type were taken out of service and quarantined.

A through-wall defect 42mm long approx. was observed, with 3 small leak paths.

- The primary factor was water/moisture on the internal surface of the cylinder, promoting corrosion. High levels of chlorides and possibly produced hydrogen may have led to the Stress Corrosion Cracking (SCC) and/or Hydrogen Stress Cracking (HSC) mechanisms.
- The root cause was suspected to be third-party testing and/or unsuitable long-term storage.

- Improvement required for technical specification for servicing, testing and inspection of bailout bottles.
- Drying procedure used by supplier deemed to be inadequate.
- Bottle receipt and storage process deemed inadequate – potentially exacerbating internal corrosion.

- Verify that third-party procedures are fit for purpose and followed.
- Improve receipt inspection and storage of bailout bottles to ensure they are dried and sealed.
