Hand injury from portable hand-held angle grinder

Safety Flash Published on 15 September 2020 Generated on 25 April 2025 IMCA SF 27/20

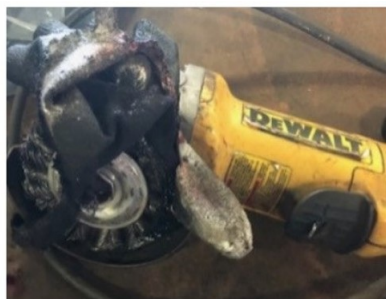
A worker was injured whilst cleaning equipment using a portable handheld angle grinder fitted with a wire brush. The rotating brush caught an edge and kicked into the worker's gloved left hand. The glove was pulled into the rotating wire brush resulting in a deep abrasion to the hand.

Glove and wire brush

- Task risk assessment amended to include all hazards and control measures.
- Angle grinder side grip handle obtained and fitted and its use made mandatory as company policy.
- Review of power tool/abrasive wheels training and competency evaluation requirements.
- Supervisors' responsibilities discussed and reaffirmed.

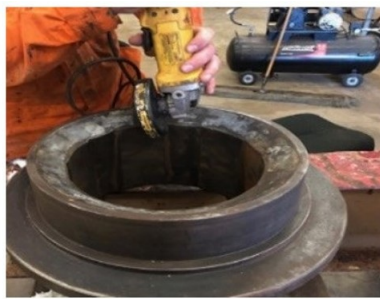
Hand position - RECONSTRUCTION

- The task risk assessment was incomplete.
- The grinder was being used without the side grip handle fitted.
- No consideration was given to where to place the hand relative to the rotating brush.
- Given the operator's position, the grinder could not be used safely.
 - The operator should have moved to the other side of the component to complete the task, and deployed the grinder in a horizontal position.
- There was no formal power tool / abrasive wheel training in place.
- There was inadequate supervision of the task.
