## Serious leg injury from falling winch sheave

Safety Flash Published on 15 September 2020 Generated on 28 January 2026 IMCA SF 27/20

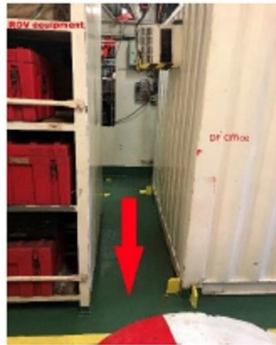
Transit between office space and storage area

Sheave positioned across walkway post
