## Finger injury: What happens when you DON'T use the right tool for the right job

Safety Flash Published on 7 November 2017 Generated on 28 January 2026 IMCA SF 28/17

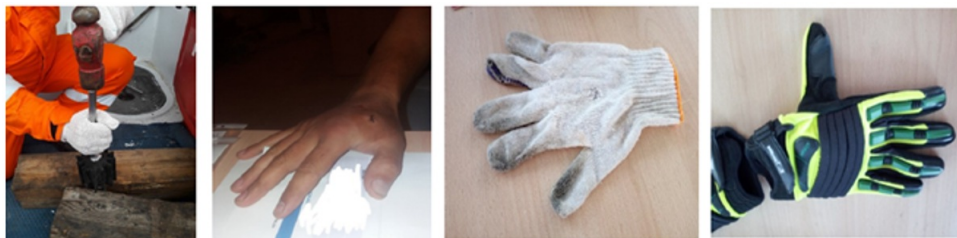
The injured person observed that the impeller was stuck on its shaft due to misaligned splines between impeller and shaft. He started to attempt removal of the impeller by knocking out the shaft using a hammer and a steel punching rod.

The punching rod splintered and the splinter went through the injured person's glove and entered the soft tissues between thumb and index finger.

- The tools selected for the job were inadequate.
- An adequate and correct gear puller specially designed for the task was not available on board.
- Inadequate hand protection equipment was used for the task; cotton gloves were used instead of mechanical impact protection gloves, which were available onboard.

- Ensure the right tools to do the job are available.

- Proper PPE, whilst a last line of defence, can minimise consequences or prevent injuries from happening.
