Unsafe boarding during unmooring operation

Safety Flash Published on 6 December 2019 Generated on 24 January 2025 IMCA SF 28/19

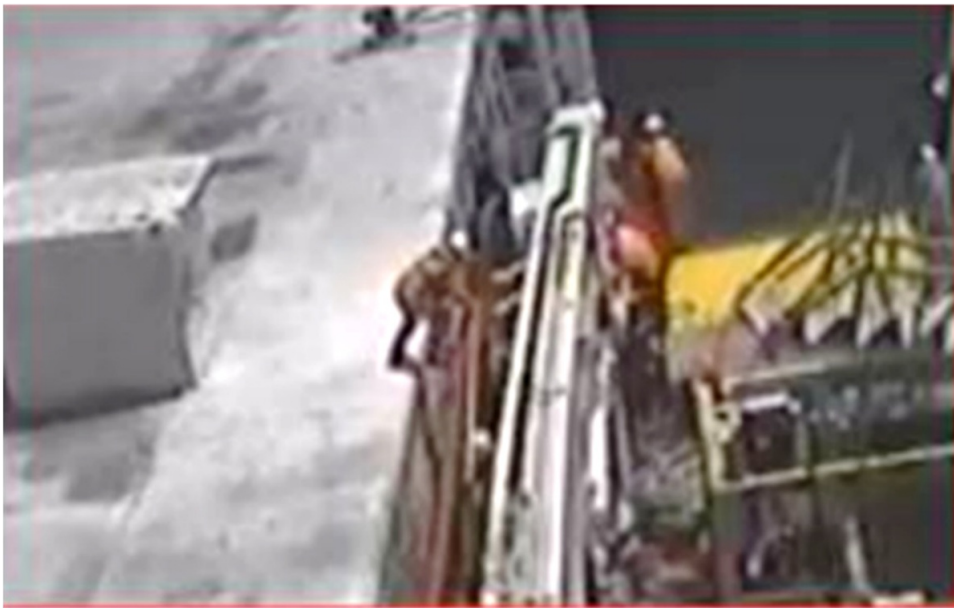
A vessel was departing from port when crew found it necessary to remove the mooring lines from the shoreside bollards with no safe un-boarding/boarding arrangements in place – instead clambering over the side (CCTV capture shown below).

A standard unmooring process (using shore-based support) had been discussed with the team involved during the pre-task briefing/toolbox talk.

- Failure to follow company operating procedures and internal HSSE rules.
- Ineffective assessment of risks before starting work.
- Failure to effectively recognise and manage the safety risks associated with the change to the planned activity (failure to manage change).
- No-one stopped the job (**stop work authority**).

- The fouled mooring line was removed/cleared from the thruster.
- Reinforcement and raising awareness of:
 - existing company rules on safety including the obligation of all employees to 'speak up/step in' if they see an unsafe act and/or condition
 - the importance of dynamic risk assessment and management of change (MoC)
 - the relevant sections of Code of Safe Working Practices for Merchant Seafarers (COSWP)
 - fleet level risk assessment and management procedures
 - fleet level vessel mooring/unmooring procedures.
- There was a visit by senior management and discussion with the team involved.

- Vessel crew should not act as linesmen for their own vessel.
- Contingency plans should be developed in advance for this type of routine activity.
- Changes to any activity should be effectively risk assessed and managed using the MoC process.
