Unsafe lifting operations

Safety Flash Published on 28 September 2020 Generated on 22 January 2025 IMCA SF 28/20

Incident 1: Unsafe lifting operations by sub-contractor

Incident 2: Master stopped unsafe lifting operation

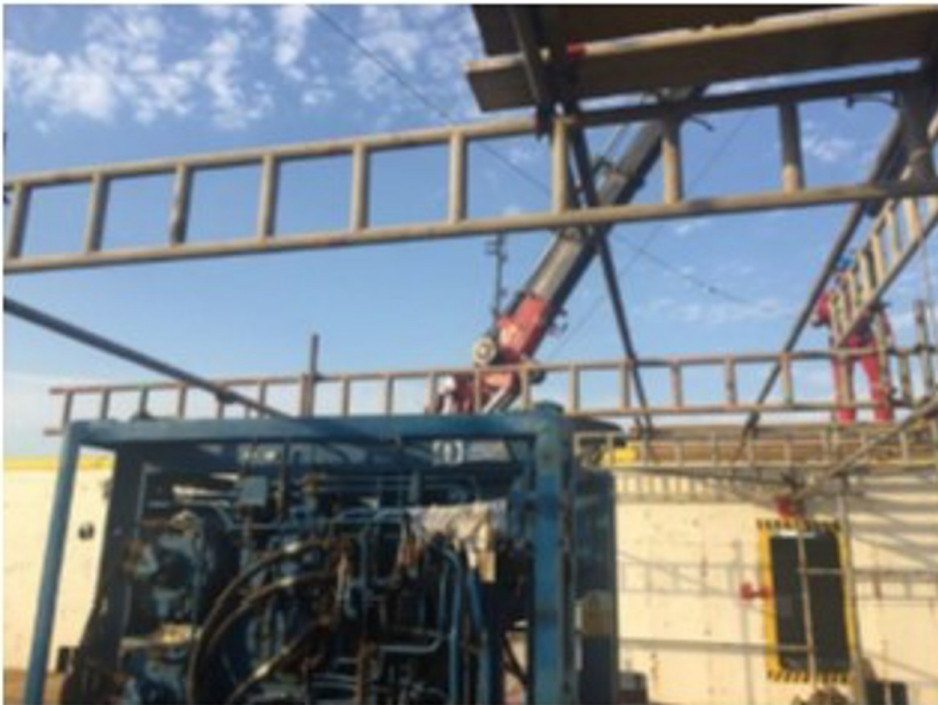
On a platform supply vessel (PSV) involved in demobilisation operations alongside, the crane operator attempted to lift a winch frame located on at the main deck while there was scaffolding structure still over the winch frame.

In addition, crew were still dismantling the scaffolding and so were in the **line of fire**.

Equipment located on deck

- Line of fire – there was scaffolding over the lifting area and the presence of

personnel in the line of fire was not considered by the contractor.

- Incorrect lifting method – scaffolding pipes were placed under the winch platform with the purpose to roll it over with partial lifting, creating a risk of the winch sliding back off its platform as it was not welded on it.
- People were in a rush – the contractor’s lifting crew were in a hurry to complete the job on that day, as windy weather was forecast for the next day.

- SIMOPS! Take into account what else is happening around you. Avoid any conflicting activities during any lifting operations.
- All lifting operations should be properly planned and risk assessed.

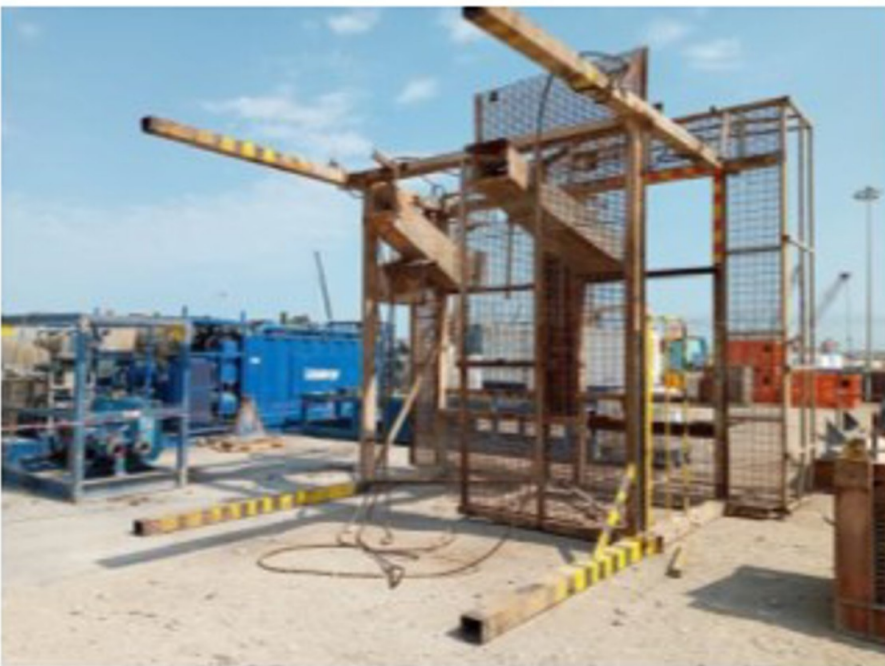
A client’s lifting crew attempted to load a metal structure to the vessel deck.

The operation was stopped by the vessel Master. He questioned the certification of the lifting point and the lifting gear, as having no colour code signs.

As no certificates could be provided, the vessel Master refused cargo and took the matter up with company management and the client’s representatives.

Metal structure proposed for lifting

- Crew to conduct vessel inspections to ensure valid colour code applied to all lifting equipment and accessories, as per Safety management system.
- Reiterate the importance of checking lifting equipment condition **before and after** the task.
