## First aid injury: Electric shock

Safety Flash Published on 6 December 2016 Generated on 24 January 2025 IMCA SF 33/16

A member has reported an incident in which an ROV Supervisor suffered an electric shock.

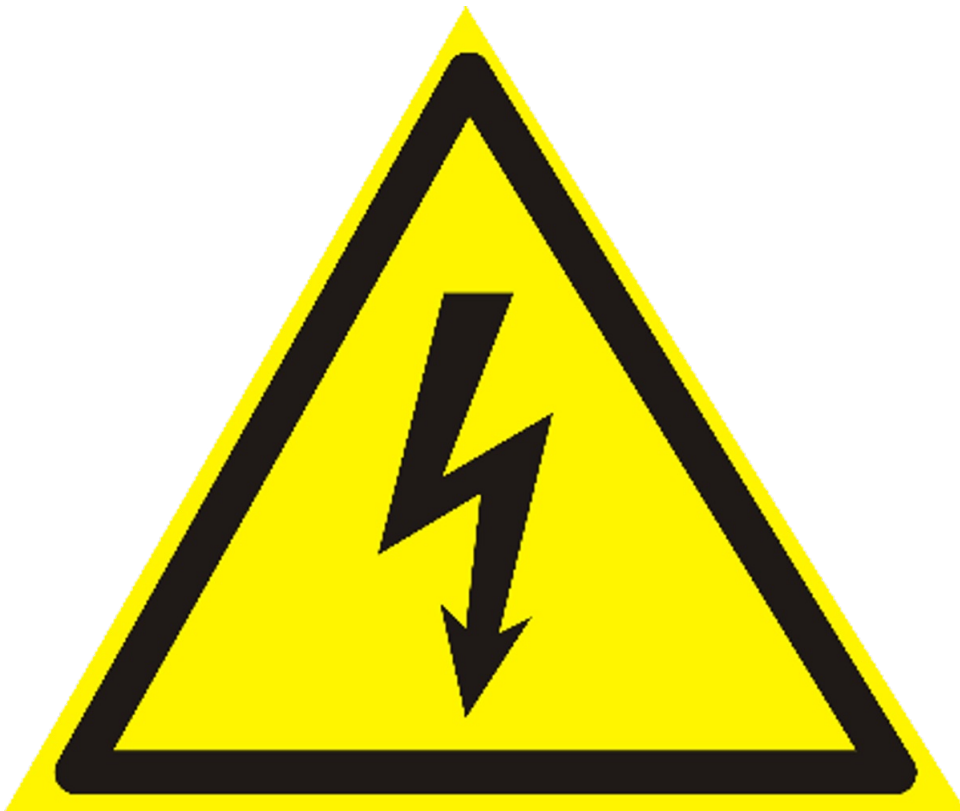
The incident occurred during ROV fault finding activities. The ROV Supervisor mistakenly accessed a transformer cabinet in the ROV Power Distribution Unit (PDU) room associated with a 2nd/alternate ROV system. He made contact with a conductor inside the transformer cabinet and sustained an electric shock which resulted in a burn to the hand requiring first aid treatment.

The power distribution system that was the focus of the fault finding activities was correctly isolated, inclusive of the discharge of stored capacitance energy, via the application of an HV spider earthing tool. The ROV system mistakenly accessed was not in use at the time, with breakers switched to the off position. However, it was receiving 40V DC from the Line Insulating Monitoring (LIM) system and was potentially a source of additional High Voltage stored capacitance energy.

- Personnel should not rely on administrative [safety] controls as the main form of defence.
- Permit to work and job hazard analysis are important planning tools; however, these should be used in conjunction with hard controls at every opportunity.

- Access to transformer cabinets and other HV energy sources should be restricted by way of lock out/tag out and a robust approval process.
- Familiarisation with the configuration of systems associated with safety critical equipment at a specific work site should be verified before approval to work is granted.

- The importance of clear labelling and the ability of crew to differentiate between similar sets of co-located equipment should be considered during installation of all safety critical equipment;

- System-specific isolation checklists and procedures should be applied to safety critical equipment.
- Stored energy should be released from offline equipment where operationally practicable.

- The practice of 'test before touch' should be reinforced as a formal requirement prior to accessing any electrical systems component.

- Review and update training and procedures to identify controls applicable to HV activities including:
  - ROV specific isolation checklist
  - Labelling/colour coding requirements for the ROV system
  - Cabinet lock management
  - Use of warning signs
  - Approved personal protective equipment (PPE) and hand tools
  - Rescue equipment, test before touch
  - Offline equipment isolation requirements
  - Adequacy of job hazard or risk analysis.
